Subject: March 30-31, 2022 SPCC Inspection Report for R+L Carriers, Inc. Wilmington Service Center (WIL Terminal); Facility ID: R5-OH-00474

Photo Log for EPA SPCC Inspection at R+L Carriers Facility on 03/30/2022 Photos taken by OSC Renninger, OSC/SPCC Inspector with US EPA Camera: iPhone 11

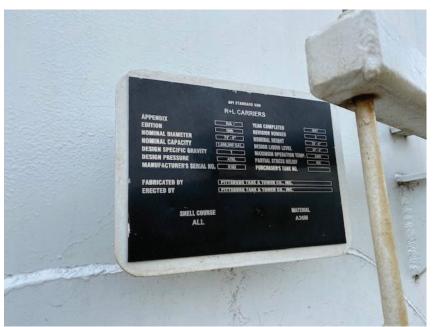
1: SPCC01

Description: Tank #27 data plate

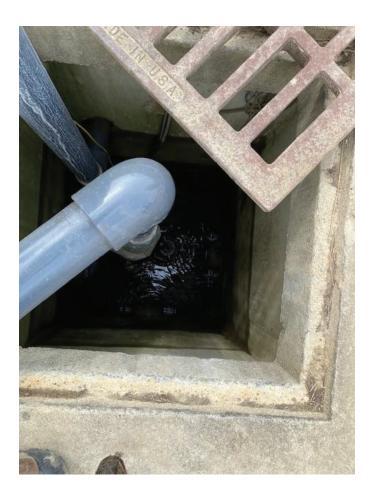
Description: Tank #27 catch basin with automatic pump. Note automatic pump in catch basin was routed to frac tanks on March 8, 2022 following spill. Prior to March 8, 2022, automatic pump discharge was to Dutch Creek approximately 100'east of catch basin outside of secondary containment.

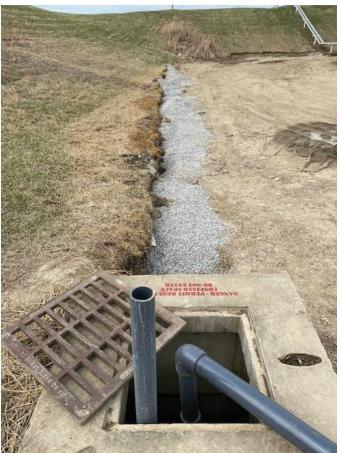
Description: Tank #27 catch basin (foreground) with subsurface perforated pipe (background) inside secondary containment. Note automatic pump in catch basin was routed to frac tanks on March 8, 2022 following spill (gray pipe). Prior to March 8, 2022, automatic pump discharge was to Dutch Creek approximately 100'east of catch basin outside of secondary containment.

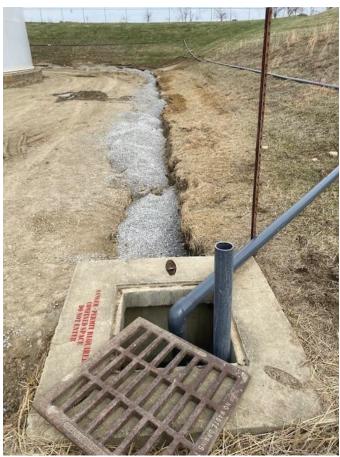
4: SPCC04

Description: Tank #27 catch basin (foreground) with subsurface perforated pipe (background) inside secondary containment. Note automatic pump in catch basin was routed to frac tanks on March 8, 2022 following spill (gray pipe). Prior to March 8, 2022, automatic pump discharge was to Dutch Creek approximately 100'east of catch basin outside of secondary containment.

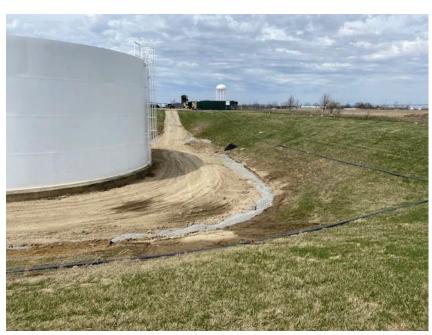
7: SPCC07

Description: Tank #27 in secondary containment. Gravel identifies where subsurface perforated pipe was excavated and replaced. Gray pipe connects catch basin to frac tanks in the background for recovery of diesel and contaminated water.

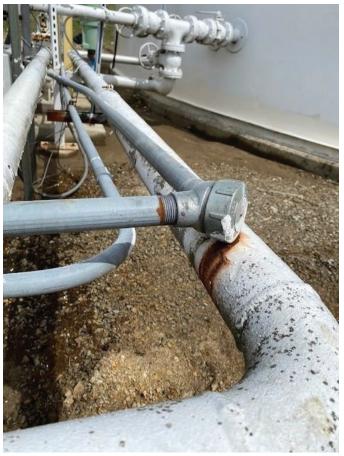
10: SPCC10 Time of Photo Taken: 1343 hours Compass Direction: North

Description: Tank #27 transfer piping with visible surface coating failure and rusting

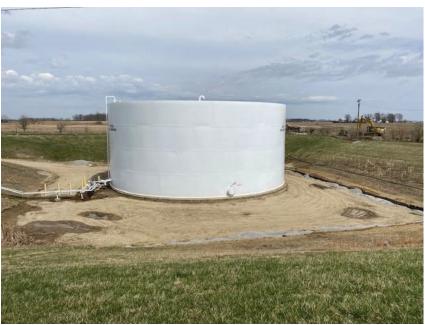
Description: Tank #27 in secondary containment. Gravel shows where subsurface perforated

pipe was excavated and replaced

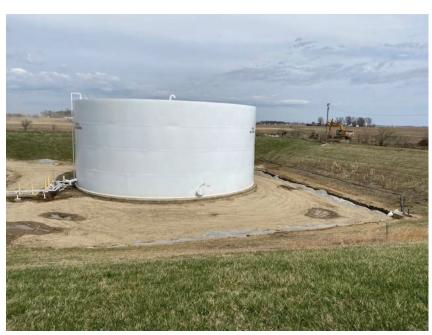
12: SPCC12

pipe was excavated and replaced. Catch basin shown in right corner

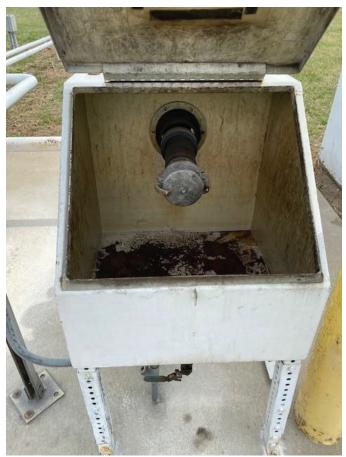
Compass Direction: East Description: Tank #27 enclosed pipe stand (transfer area)

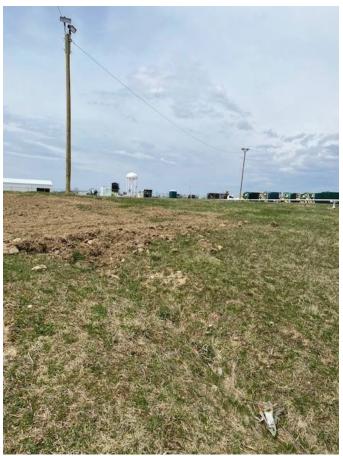
Compass Direction: North
Description: Tank #27 secondary containment surface drainage

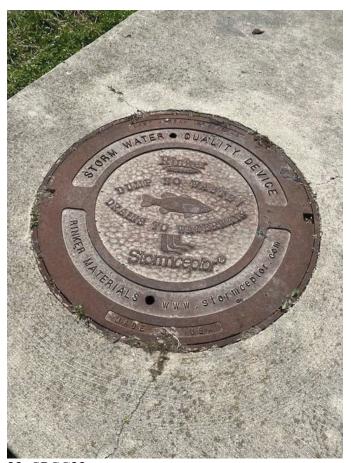
22: SPCC22 Time of Photo Taken: 1407 hours Compass Direction: Ground

Description: Tank #27 loading/unloading rack and transfer area (concrete pad) cover of stormwater quality device ("stormceptor").

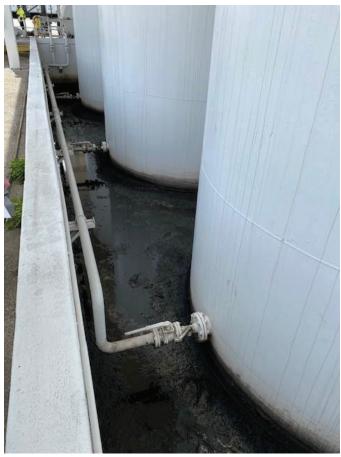
29: SPCC29
Time of Photo Taken: 1423 hours
Compass Direction: South

Description: Fueling Island Tanks #23 (three, 20,000-gal diesel tanks) in secondary containment. Note visible staining in secondary containment and on tanks; containment observed to be filled with a mixture of sludge, oil, and water.

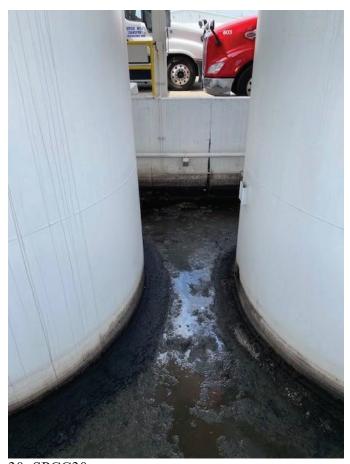
30: SPCC30 Time of Photo Taken: 1424 hours Compass Direction: West

Description: Fueling Island Tank #23 secondary containment. Note visible staining in secondary containment and on tanks; damage/cracking of secondary containment wall; containment observed to be filled with a mixture of sludge, oil, and water.

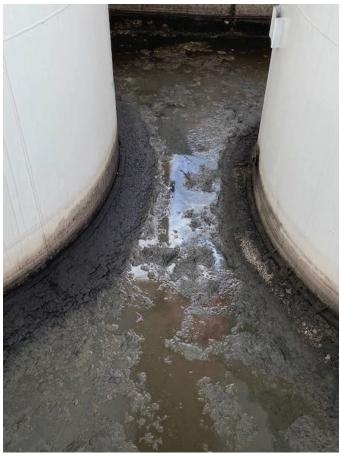
31: SPCC31
Time of Photo Taken: 1424 hours
Compass Direction: West

Description: Fueling Island Tank #23 secondary containment. Note visible staining in secondary containment and on tanks; containment observed to be filled with a mixture of sludge, oil, and water.

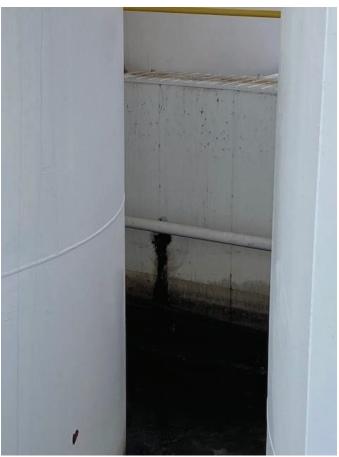
33: SPCC33 Time of Photo Taken: 1427 hours

Description: Fueling Island Tank #23 secondary containment with visible staining on containment wall. Note hole in containment wall where staining appears to originate was observed to have an open pipe connecting the containment for Tank #22 to the containment for Tank #23.

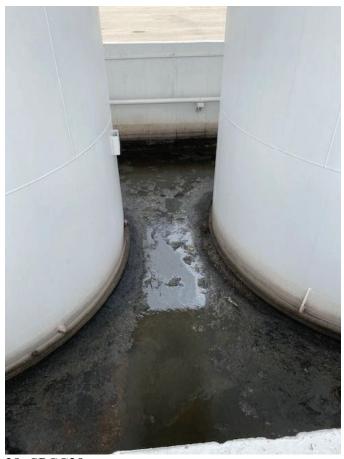
39: SPCC39 Time of Photo Taken: 1434 hours

Description: Fueling Island Tank #23 secondary containment. Note containment observed to be filled with a mixture of sludge, oil, and water.

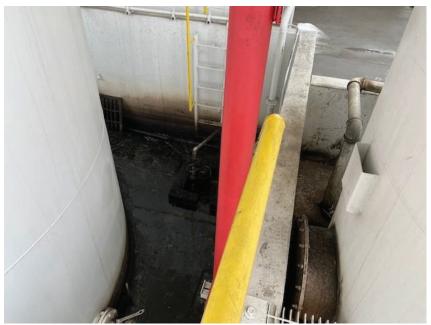
Description: Fueling Island Tank #23 (left) and Tank # 22 (right) and secondary containment. Note visible staining on containment walls and floor; Tank #22 manway observed to be leaking; Tank #23 containment observed to be filled with a mixture of sludge, oil, and water; an open pipe was observed connecting the containment for Tank #22 to the containment for Tank #23.

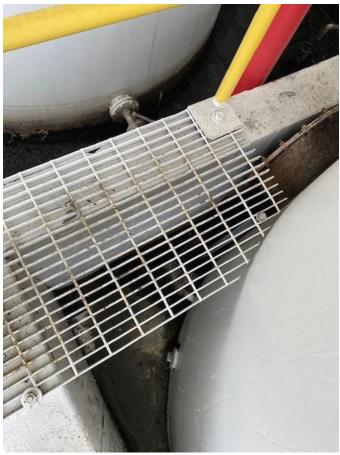
47: SPCC47
Time of Photo Taken: 1446 hours
Compass Direction: South

Description: Fueling Island Tank #23 (top) and Tank # 22 (bottom) and secondary containment. Note visible staining on containment wall and floor; an open pipe was observed connecting the containment for Tank #22 to the containment for Tank #23.

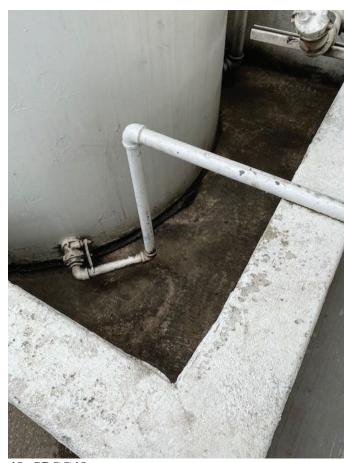
48: SPCC48
Time of Photo Taken: 1447 hours
Compass Direction: South

Description: Fueling Island Tank # 22 and secondary containment. Note heavy visible staining on bottom of tank and containment floor and wall.

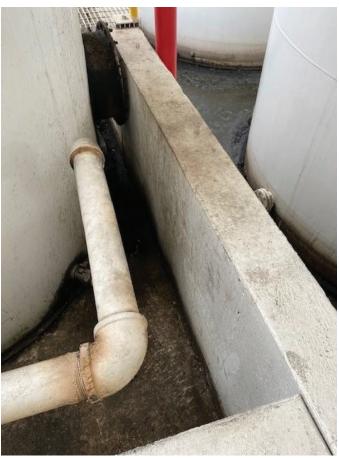
49: SPCC49 Time of Photo Taken: 1448 hours

Description: Fueling Island Tank #22 (left) and Tank # 23 (right) and secondary containment. Note heavy visible staining on bottom of Tank #22 containment floor and wall; Tank #22 manway was observed to be leaking; Tank #23 containment was observed to be filled with a mixture of sludge, oil, and water; an open pipe was observed connecting the containment for Tank #22 to the containment for Tank #23.

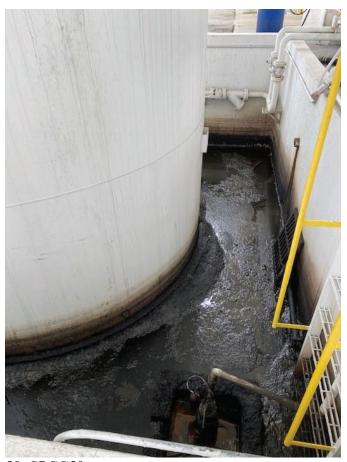
50: SPCC50 Time of Photo Taken: 1448 hours

Description: Fueling Island Tank #23 secondary containment showing staining on tank walls and containment walls. Sump pump in foreground. Note containment observed to be filled with a mixture of sludge, oil, and water; an open pipe was observed connecting the containment for Tank #22 to the containment for Tank #23.

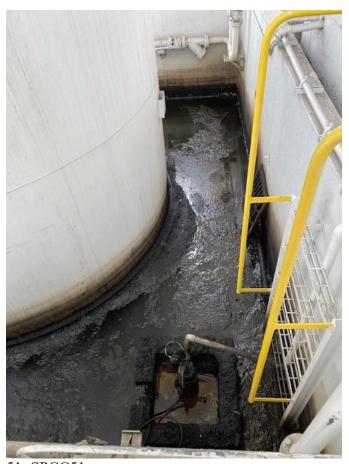
51: SPCC51 Time of Photo Taken: 1449 hours

Description: Fueling Island Tank #23 secondary containment and sump pump. Note: containment observed to be filled with a mixture of sludge, oil, and water, and sump pump was observed to be running.

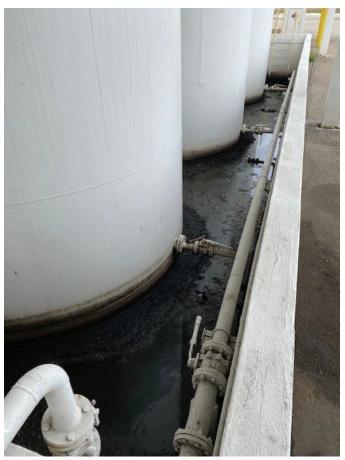
55: SPCC55 Time of Photo Taken: 1513 hours Compass Direction: North

Description: Fueling Island Tank #23 secondary containment showing staining on tank walls, containment walls and floor. Note containment observed to be filled with a mixture of sludge, oil, and water.

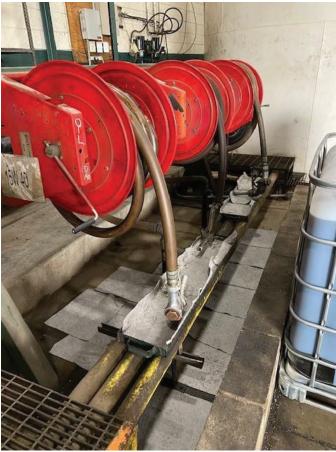
Note staining on containment walls and floor and visible absorbent pads on floor.

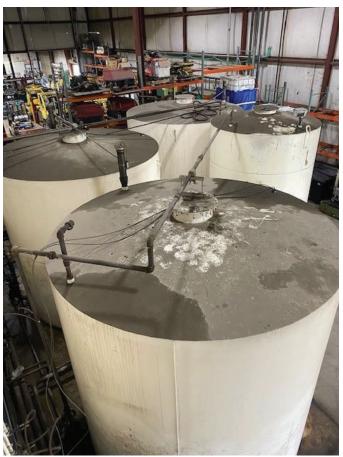
and 14 (left). Note staining on top of tanks and piping; dent at top of Tank #12.

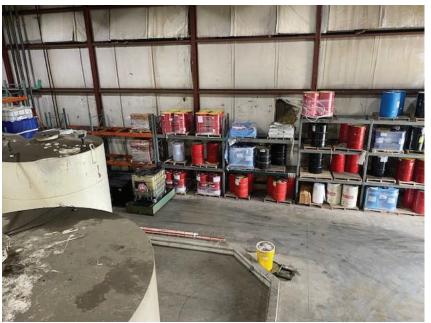
Note visible staining on tank roofs; dent at top of Tank #12.

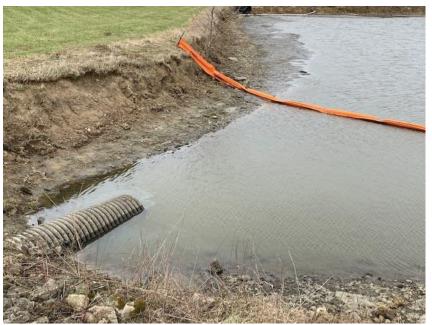
Description: Retention Pond outfall pipe. Note the use of boom and sheen at pipe entrance. Note sheen was also observed behind the hard boom entering the discharge pipe; walls of Retention Pond have been excavated due to previous oil staining.

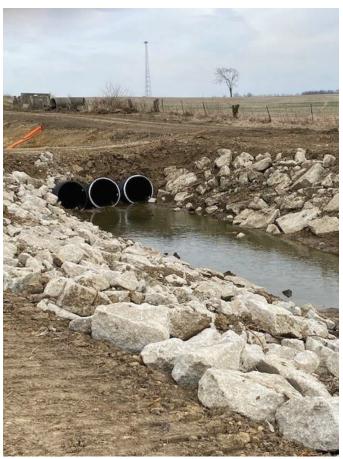
83: SPCC83
Time of Photo Taken: 1735 hours
Compass Direction: North

Description: Recovery Location 0.5. This oil recovery location was installed in March 2022 following spill and where the 36" subsurface pipe discharges to Dutch Creek. Outfall is at top left where there are three 36' pipes creating an underflow dam.
